# Tributaries Forest Recovery Project

## Road Survey Report

Hungry Creek and Little Grizzly Creek Subwatersheds

Prepared for Plumas Corporation  
Ken Roby  
Feather River Chapter, Trout Unlimited  
December 2023

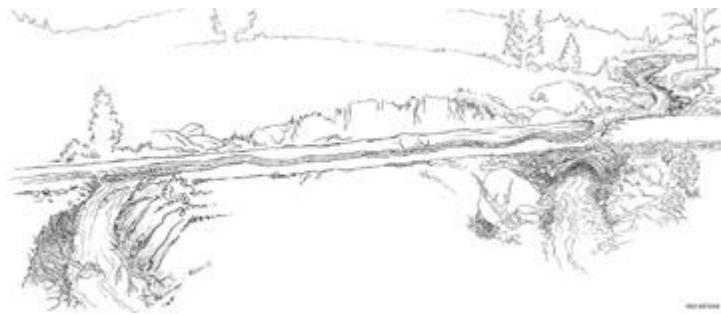
*Figure 2. The probability of failure is substantial for most crossings, so how they fail is of critical importance. In this sketch, the crossing has failed, and the road grade has diverted the streamflow out of this channel and down the road, resulting in severe erosion and downstream sedimentation. Such damage to aquatic habitats can persist for many years once begun (from Furniss, et al, 1997).*

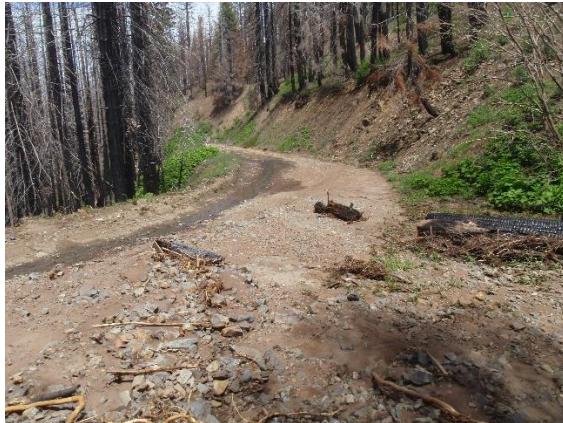
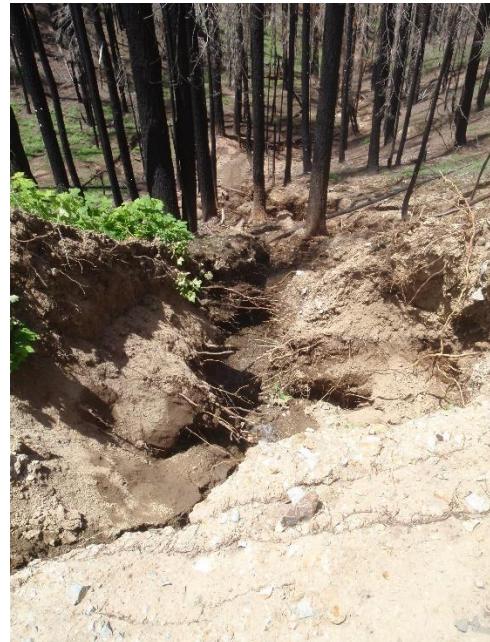
*Figures 3A-B. Example of crossing (site H7) where plugged culvert failed resulted in flow diversion, in this case a long run along the roadway (3A) with gullying where flow finds a return path to the stream channel (3B).*

Impacts of this event were observed at sites H7 and H8. These sites were first surveyed on June 6<sup>th</sup>. Diversion potential was identified

at both sites, but culvert inlets were not obstructed. The sites were revisited on June 26<sup>th</sup>. Both culverts were completely blocked, and channel flow had been diverted down the roadway. Catchments upstream of both crossings were severely burned.

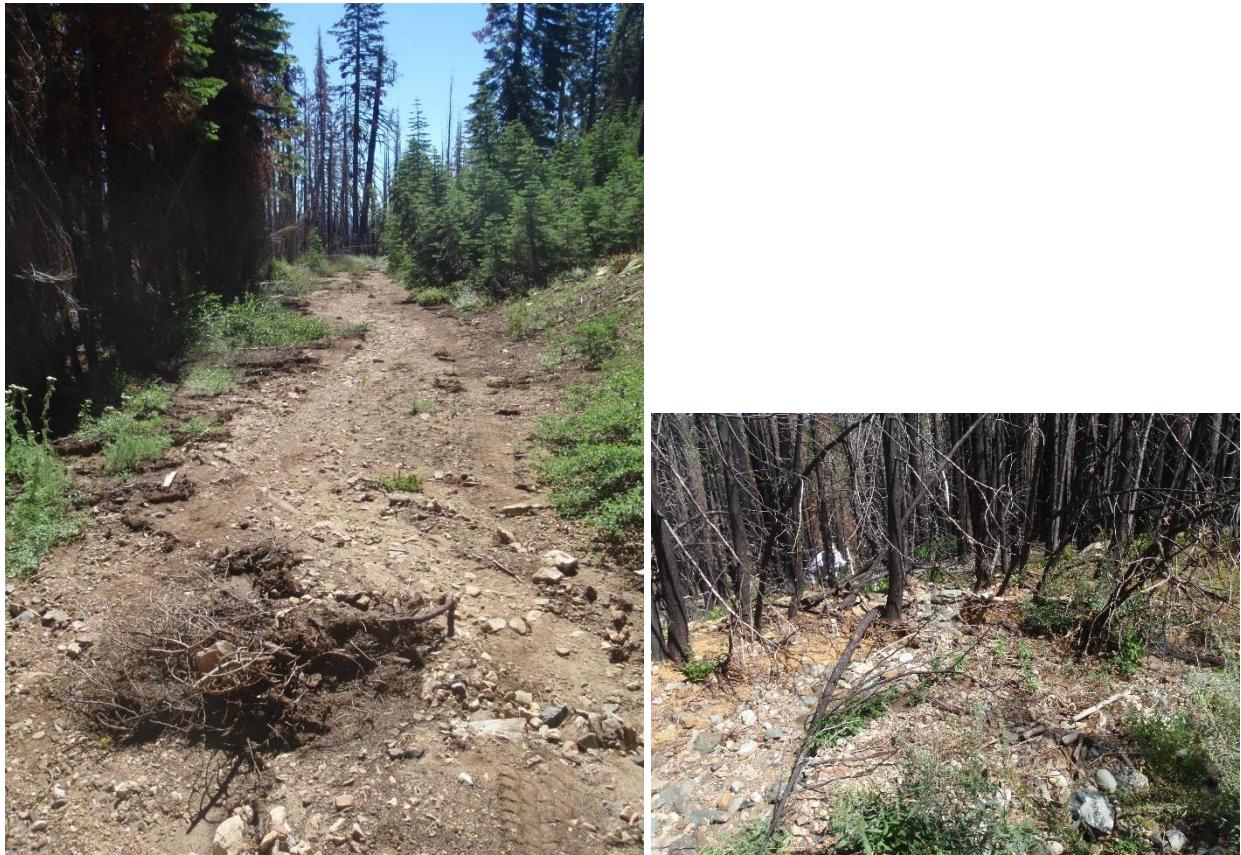
Gullies formed by diverted flows in roadways and return slopes to channels represented a high percentage (84% in Hungry, 86% in Little Grizzly) of all estimated road generated sediment. Eroded volumes ranged from 3 to 155 Cubic Yards (CY) and averaged just over 53 CY per site. Note that of the 16 crossings with diversion potential in Hungry Creek and 26 in Little Grizzly, only 5 in Hungry Creek (31%) and 9 in Little Grizzly Creek (35%) have failed and currently divert flow. Roughly two thirds of the remaining crossings with diversion potential pose a high risk of delivering large quantities of sediment to channels in the future. Examples of erosion following channel diversion are shown in Figure 7 A-B, and in Figure 3 above.

*Figures 7A-B. Example of road surface erosion (7A) resulting from culvert failure and diversion of flow onto roadway. Erosion also occurs where flow leaves roadway and returns to channel, as shown in Figure 7B. Site is LG 33 on FS road 24N08X.*

**Road 24N08X.** This spur road is the site of several of the worst sediment producers encountered in the road surveys. The road has not been maintained, and is overgrown to the point where it is impassable by passenger vehicles. We recommend either decommissioning this road, or closing it after pulling culverts and constructing waterbars to prevent delivery of flow and sediment from road surfaces. We note also

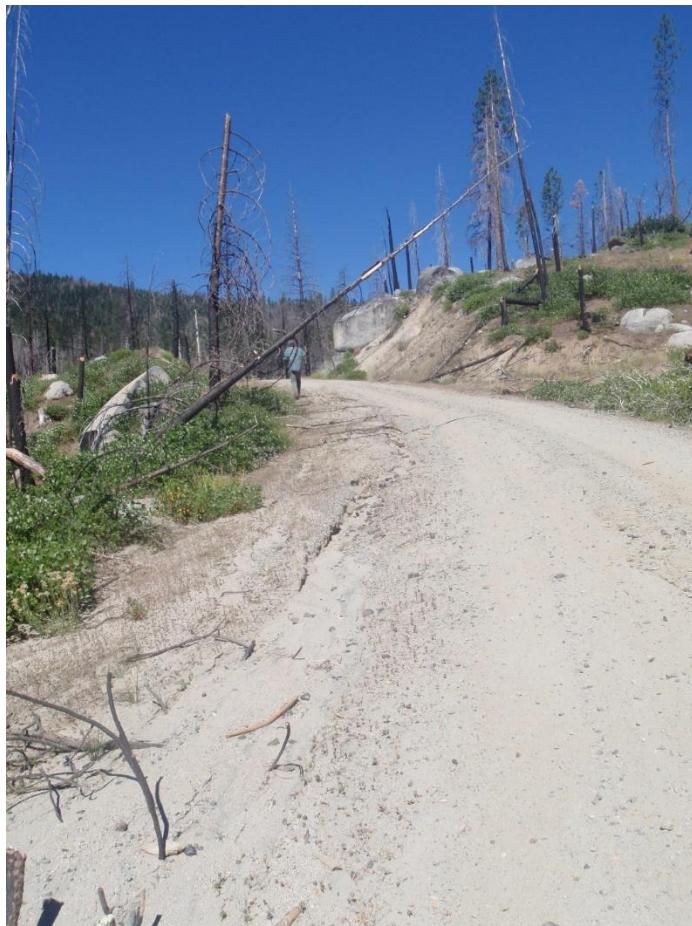
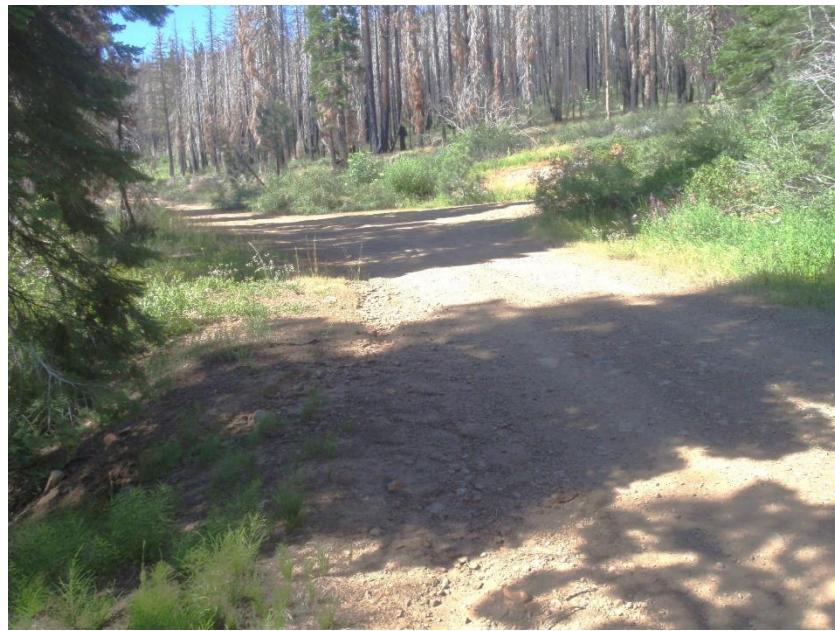
Figures 8 and 9. Examples of surface rilling from Hungry Creek Subwatershed (Site H11, Road 27N09) and Little Grizzly Creek (Site 56, Road 24N09).

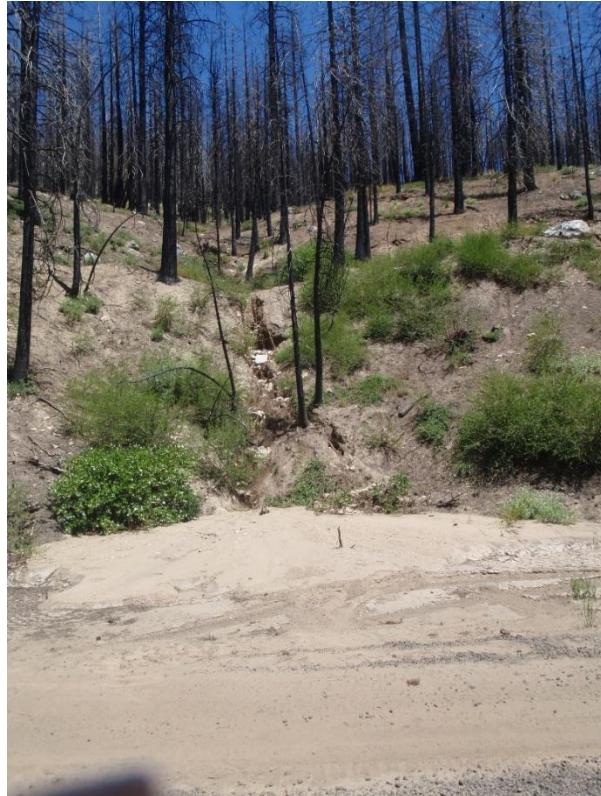
Several culverts surveyed were completely plugged (example, Figure 10). While the composition of the material at the plug inlets was primarily fine sediment, it is likely that either bedload or bedload and debris contributed to clogging the pipe inlets. As might be expected there was a strong correlation between diverted stream flows at crossings and plugged inlets at those crossings. Tables 11 and 12 include lists of crossings with culvert inlets either plugged or with capacity reduced by greater than 50% in Hungry and Little Grizzly, respectively. Location of these culverts is shown in Figure 11.

Figure 10. Plugged culvert inlet at site H17, road 27N09
