# Tributaries Forest Recovery Project

## Road Survey Report

Hungry Creek and Little Grizzly Creek Subwatersheds

Prepared for Plumas Corporation  
Ken Roby  
Feather River Chapter, Trout Unlimited  
December 2023

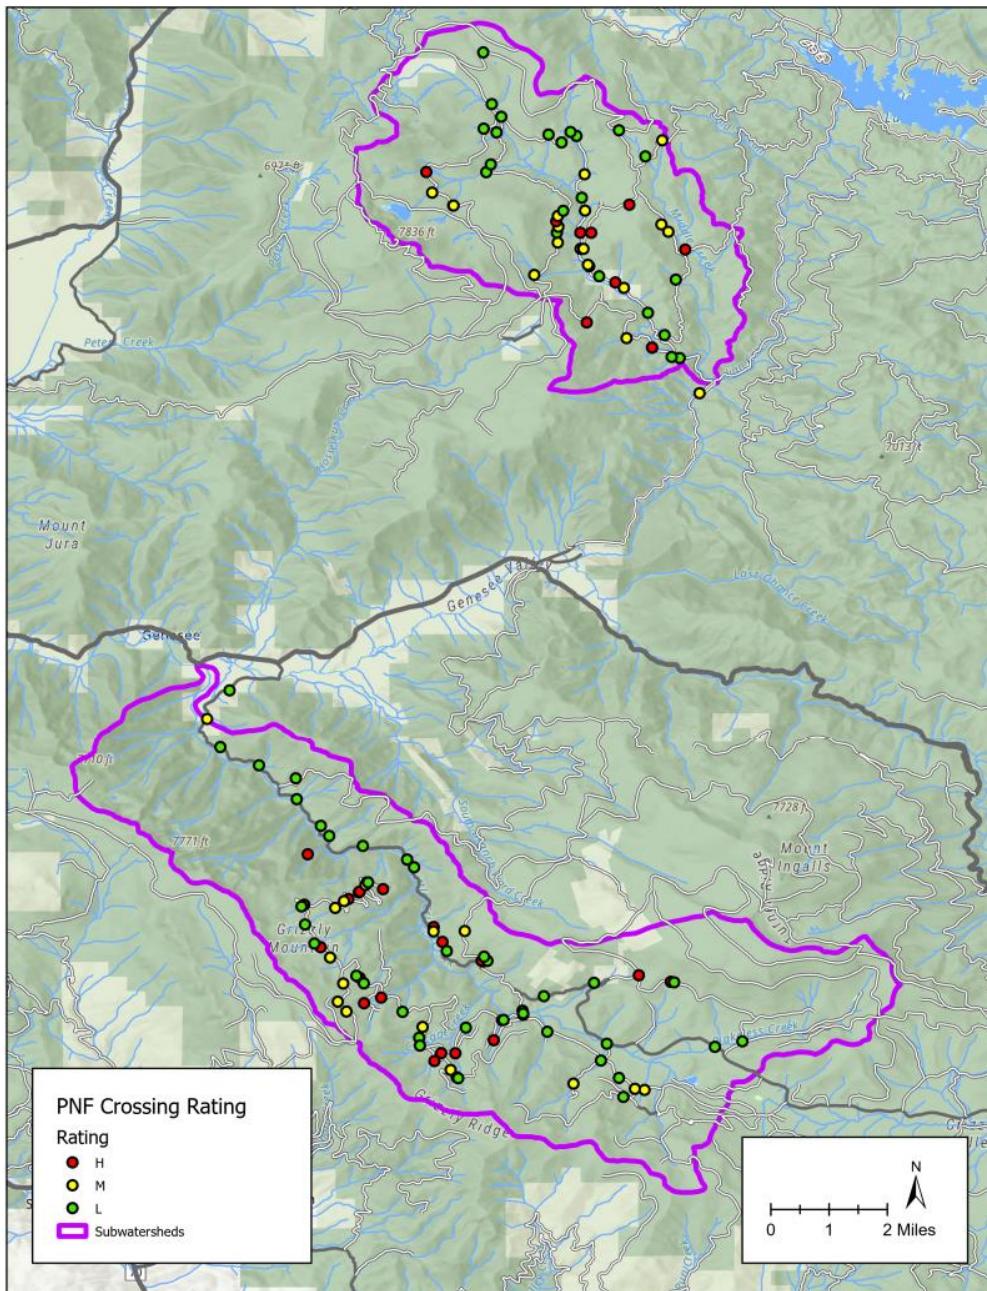
Figure 4. Location of Road Crossing Surveys with PNF Crossing Rating, Hungry and Little Grizzly Creek subwatersheds

Crossing ratings using the PNF road crossing rating scheme are summarized in Table 3. The results are shown in Figure 4 which includes the location of all crossings surveyed. Roughly a fifth of crossings in Hungry Creek and a quarter of Little Grizzly Creek crossings were rated as having high risk of impacts to water quality.

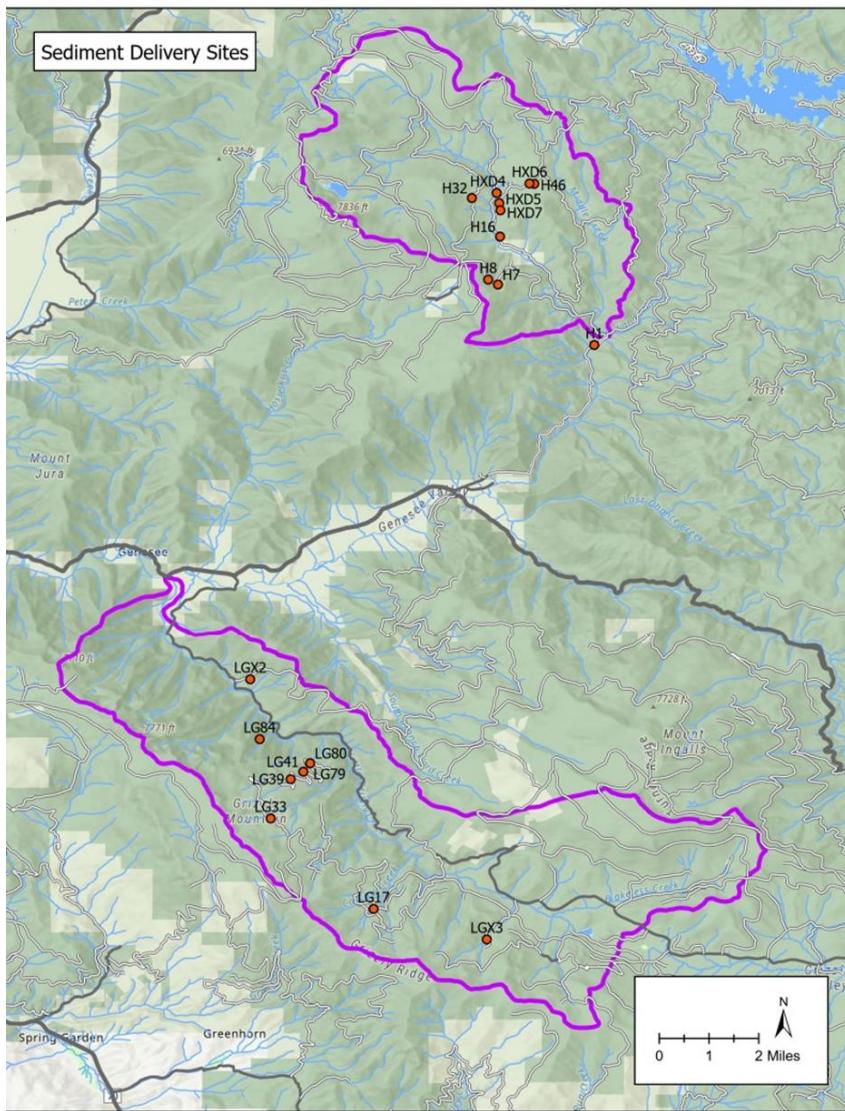
Figure 5. Location of road crossings with greatest sediment delivery, Hungry and Little Grizzly subwatershed

Site #	Road	% sediment	Latitude	Longitude
LG80	24N08X	27.46	39.9872	-120.727
LG84	24N08X	20.99	39.99417	-120.742
LG17	24N42	12.61	39.94496	-120.709
LG79	24N08X	6.60	39.98714	-120.727
LG33	24N08X	6.05	39.97116	-120.739
LGX2	25N06Y	5.23	40.01152	-120.745
LG41	24N08X	4.50	39.98474	-120.729
LGX3	25N06Y	3.56	39.93612	-120.676
LG39	24N08X	2.80	39.98258	-120.733

Table 6. Road crossings accounting for 90% estimate sediment delivered, Little Grizzly Creek Subwatershed

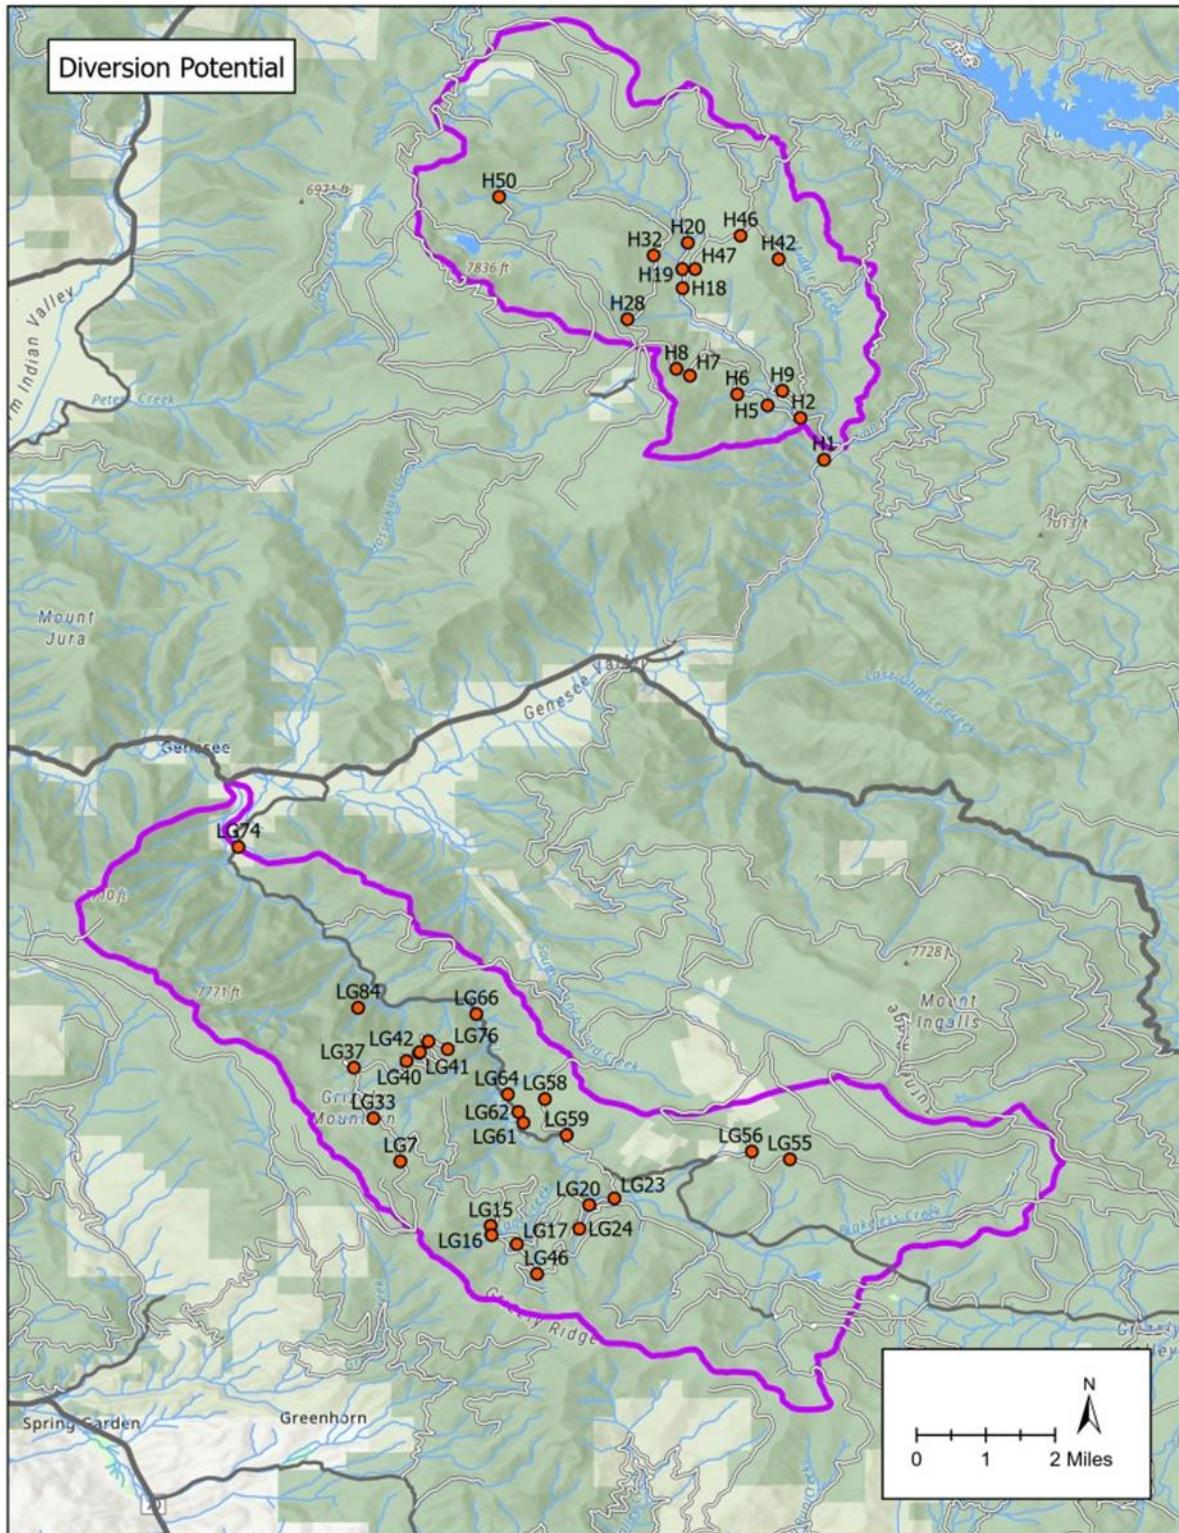
Figure 6. Location of crossings with diversion potential Hungry Creek and Little Grizzly Creek subwatersheds.

Roughly a third of road crossings in both Hungry Creek and Little Grizzly Creek subwatersheds were found to have the potential to divert flow from channels should the crossings fail. These results are similar to findings in other surveyed watersheds (Roby and Rogers, 2018, Roby and Rogers, 2019). Frequency of crossings with diversion potential from these 4 subwatersheds on the Plumas and Lassen National Forests ranged from 19 to 46 percent, with an average of 31%. Lists of sites with diversion potential are presented in Tables 7 and 8. Locations of the sites are shown in Figure 6.

Site	Road	Latitude	Longitude	Site	Road	Latitude	Longitude
LG7	25N42	39.96219	-120.733	LG55	24N11	39.96262	-120.652
LG15	24N42	39.94879	-120.714	LG56	24N09	39.96423	-120.66
LG16	24N42	39.94683	-120.714	LG58	25N42	39.97518	-120.703
LG17	24N42	39.94496	-120.709	LG59	CR112	39.96765	-120.698
LG20	24N42	39.95311	-120.694	LG61	CR112	39.97023	-120.707
LG23	24N42	39.95449	-120.689	LG62	CR112	39.97248	-120.709
LG24	24N60B	39.94816	-120.696	LG64	CR112	39.97616	-120.711
LG33	24N08X	39.97116	-120.739	LG66	CR112	39.99288	-120.717
LG37	24N08X	39.9817	-120.743	LG74	CR112	40.02797	-120.767
LG40	24N08X	39.98309	-120.732	LG76	24N08X	39.98556	-120.723
LG41	24N08X	39.98474	-120.729	LG79	24N08X	39.98714	-120.727
LG42	24N08X	39.98494	-120.729	LG80	24N08X	39.9872	-120.727
LG46	24N42D	39.93875	-120.705	LG84	24N08X	39.99417	-120.742

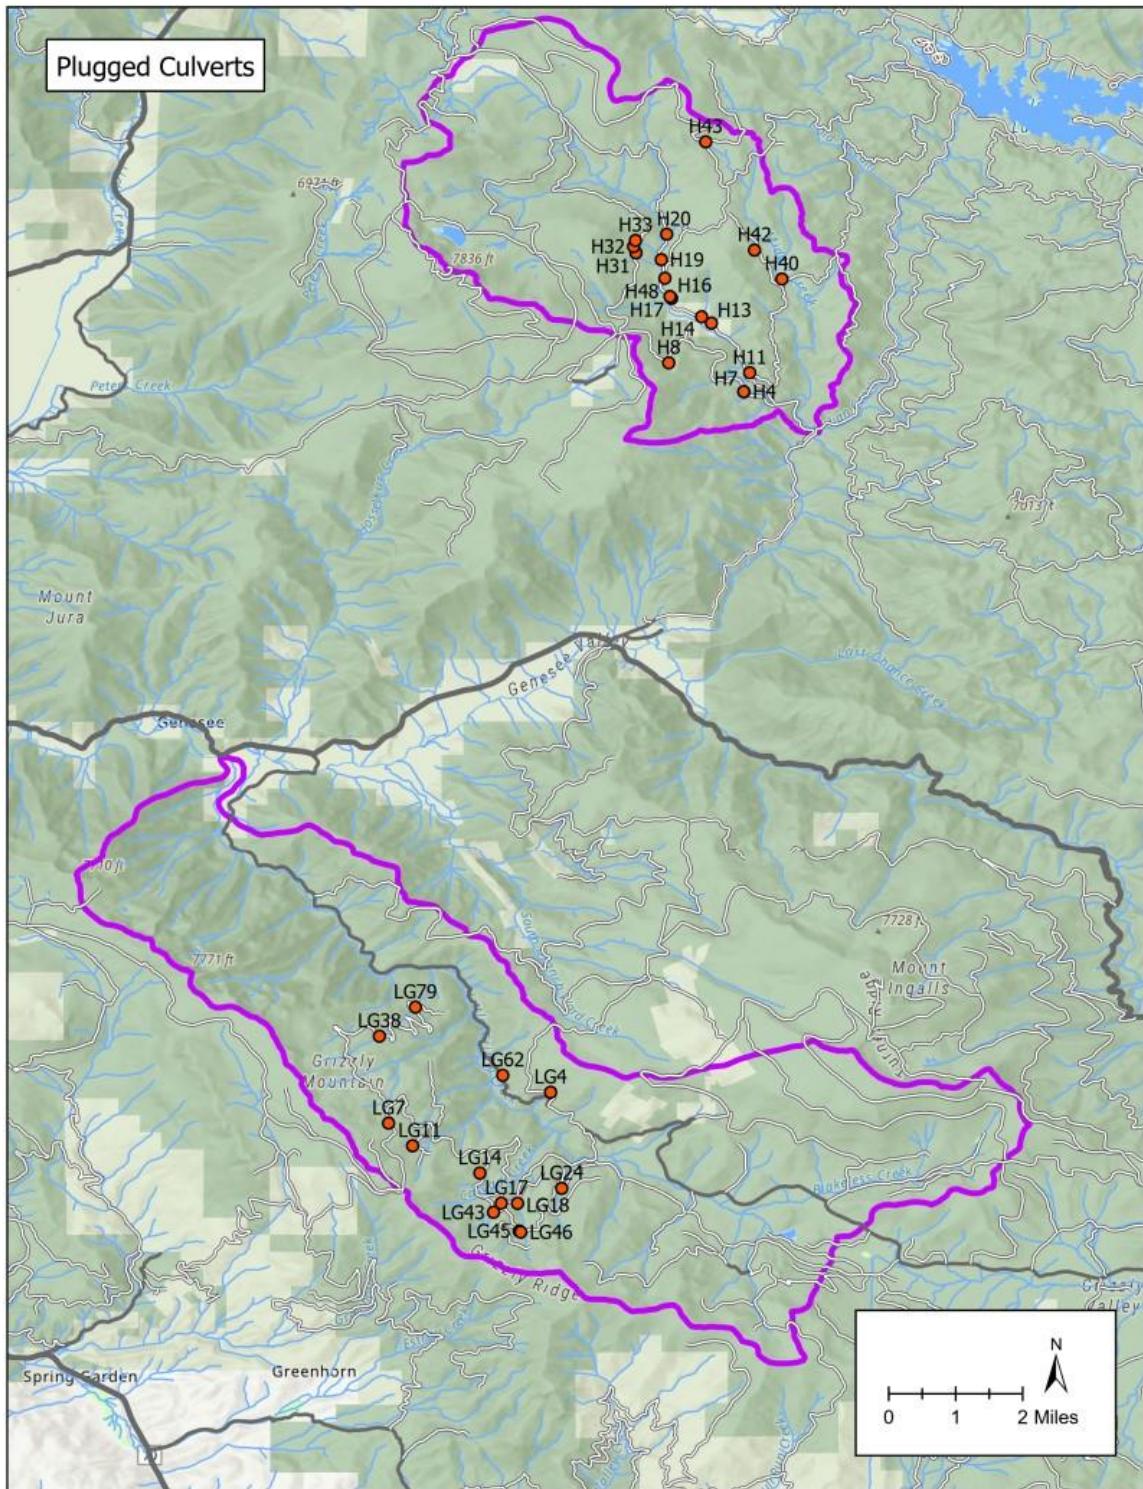
Figure 11. Location of crossings with plugged culverts Hungry Creek and Little Grizzly Creek subwatersheds.

Several culverts surveyed were completely plugged (example, Figure 10). While the composition of the material at the plug inlets was primarily fine sediment, it is likely that either bedload or bedload and debris contributed to clogging the pipe inlets. As might be expected there was a strong correlation between diverted stream flows at crossings and plugged inlets at those crossings. Tables 11 and 12 include lists of crossings with culvert inlets either plugged or with capacity reduced by greater than 50% in Hungry and Little Grizzly, respectively. Location of these culverts is shown in Figure 11.

Site #	Road	Size (inches)	% Plugged	Latitude	Longitude
LG11	24N94Y	36	100	39.95731	-120.728
LG14	24N42	18	100	39.95145	-120.713
LG17*	24N42	18	100	39.94496	-120.709
LG43	24N42D	18	100	39.943	-120.711
LG46	24N42D	18	100	39.93875	-120.705
LG7*	25N42	18	100	39.96219	-120.733
LG79	24N08X	36	100	39.98714	-120.727
LG45	24N42D	18	97	39.93898	-120.705
LG38	24N08X	24	85	39.98091	-120.735
LG4	25N42	18	80	39.96883	-120.698
LG18	24N42	42	60	39.94493	-120.705
LG24*	24N60B	40	50	39.94816	-120.696
LG62	CR112	8	50	39.97248	-120.709

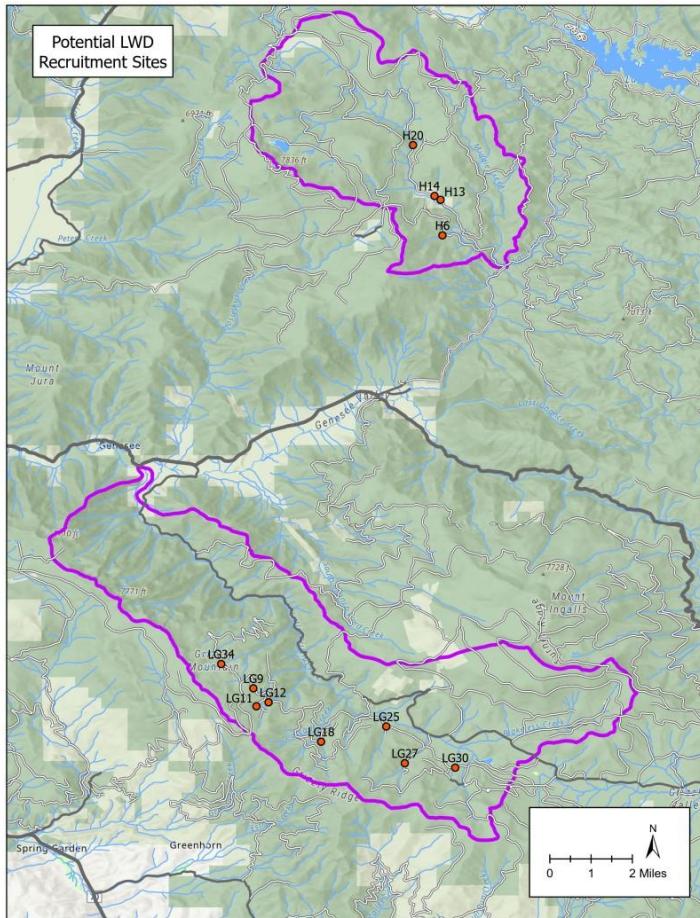
Figure 12. Location of channels with possible LWD recruitment opportunities.

We found it difficult to consistently identify channels that might benefit from addition of standing dead trees. In general, the vast majority of channels observed were steep (>2% channel slope), and we were certain channels were “too steep”. Nevertheless, we did identify several locations (listed in Table 14, shown in Figure 12) that we feel met the criteria, and might benefit from addition of LWD. We caution that more evaluation of these sites should be conducted before treatment prescriptions are proposed.

Site #	Road	Latitude	Longitude	Site #	Road	Latitude	Longitude
H6	27N53	40.1224	-120.663	LG11	24N94Y	39.95731	-120.728
H13	27N09	40.13484	-120.664	LG12	24N42	39.95871	-120.724
H14	27N09	40.1362	-120.666	LG18	24N42	39.94493	-120.705
H20	27N09	40.154	-120.673	LG25	24N60	39.95025	-120.683
				LG27	24N60C	39.93741	-120.676
				LG30	24N57	39.93586	-120.658
				LG34	24N08X	39.97208	-120.74
				LG9	25N42	39.9636	-120.729
